Overview of the 1st Quarter 2008 Surveillance and Maintenance Report for the DOE LM Rocky Flats Site

Rocky Flats Stewardship Council
August 4, 2008

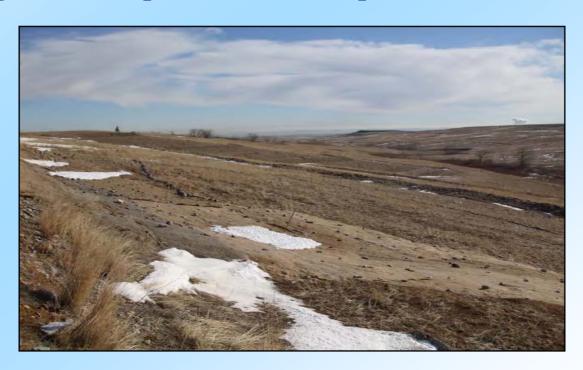
Original Landfill – Seeps and Slumps

Seep #7 was dry for first quarter.

Seeps #4 and #8 showed active groundwater seepage throughout 1st quarter ~ 1-3 gpm.

Slumping areas of OLF continued to be monitored; no significant changes.

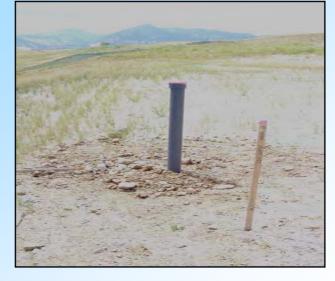
Original Landfill – Geotechnical Investigation

The investigation was completed to determine subsurface conditions and the possible causes of observed localized slumping and settling of the OLF cover.

Nine test pits were excavated from February 12 - 20.

Seven boreholes were drilled beginning on March 27 and extending into second quarter 2008.

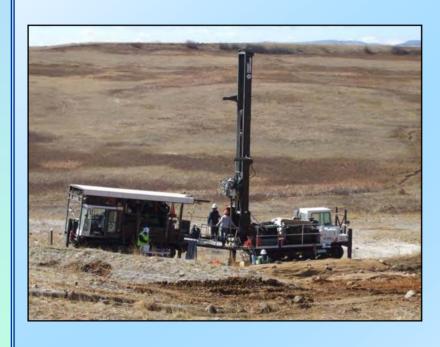
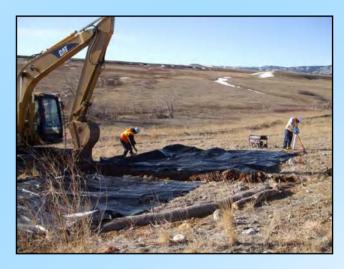
Original Landfill Investigation and Path Forward

- 8 test pits ~ 20' long x 11-13' deep
 - Ninth test pit ~ 3'deep (to buttress drain depth)
- 7 boreholes ~ 28-39' deep (into bedrock)
 - Continuous core samples
 - Inclinometers to accurately measure movement
- Clay layer with organic materials appears to be a weak interface area
 - Percolating moisture lubricates
 - Modeling predicts small-scale instability
- Buttress performing as modeled
 - No large-scale OLF instability

- Migration of surface water from upslope areas
 - Preferential pathways and porous zones intersect ground surface
- Slope failures appear to shift pathways somewhat
 - Seep volume and occurrence change over time
- Seep #8 likely from water collected by buttress drain
 - Collected water not adequately percolating through subsurface as intended
- Directing seep water that surfaces on cover to perimeter channels/buttress drain will improve weak layer stability

- High and low spots in channel allow minor ponding in low-flow condition.
- Heights below 2 feet due to minor settlement and localized slumping.
 - High-flow (24 hour/100 year and 1,000 year event model) condition would overtop the berms.

- Repair localized slumping/differential settlement by filling/grading.
 - Area below Berm #1 repaired last summer with good results.
- Fill/regrade perimeter channel to reduce slope and improve stability at berm ends, as needed.
- Two-foot berm height difficult adjust height along length based on sub-basin model.
- Conduct routine maintenance for observed ponding in berm channels - regrade high and low spots.
- Install extension to Seep #7 drain to direct water to buttress drain.
